Snowy Hydro Limited Murray Two Power Station Khancoban Project

Nuflow Albury-Wodonga were contracted by Snowy Hydro Limited to use their relining technology to repair a 150mm compressor line, at the Murray 2 Power Station. This stainless steel pipe which has working pressures of 750KPa had been identified to be leaking.

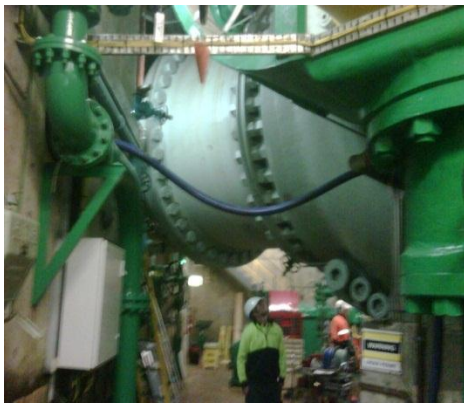
CCTV Inspection

The inspection of the pipe found numerous stainless steel welds throughout its distance. One of these welds in particular had failed, due to stress and vibration caused by continuous high working pressure. These spiral weld joints on the inner circumference made an ideal bonding condition for the liner to adhere.

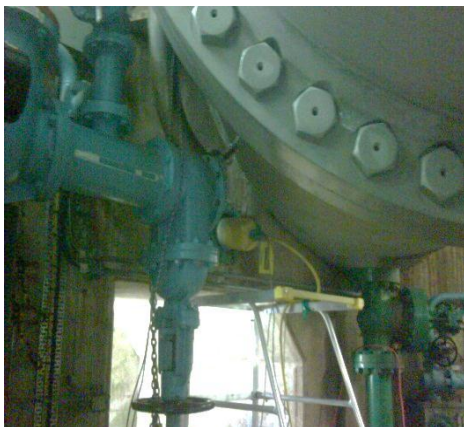
Results after relining

Length of liner: 2.8m, one continuous 150mm liner without bends.

Downtime: The procedure was completed in 4 hours coinciding within the facility's rotational maintenance schedule. This meant zero downtime to the vital operations of the power station.
