Young Street Albury NSW

CCTV Investigation

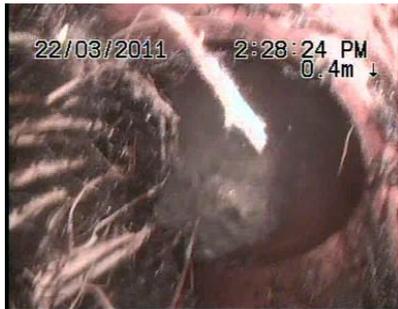
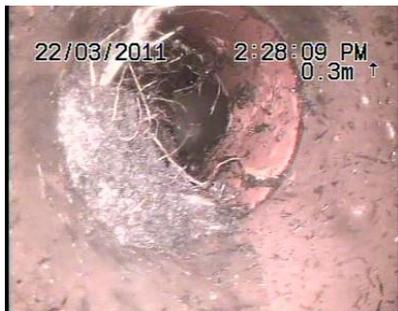
The toilet suite was removed for access and immediately below the floor level of the external wall was a mass of tree roots penetrating fractures in the base and branch arm of the 100mm earthenware junction (images left.)

It was clear that this was causing the backups as well as severe sewerage leakage around building foundations.

We also noticed substantial fractures in the drain riser of the shower in the same bathroom.

The line required jetting to remove the tree roots in order to clear the blockage and allow us to repair the damaged junction.

Excavation: a small hole was dug in the garden to access an inspection opening and gain a downstream point to pull in the junction liner.

Type of liners: One 45 degree junction liner 500mm each direction and a 500mm patch for the shower riser.

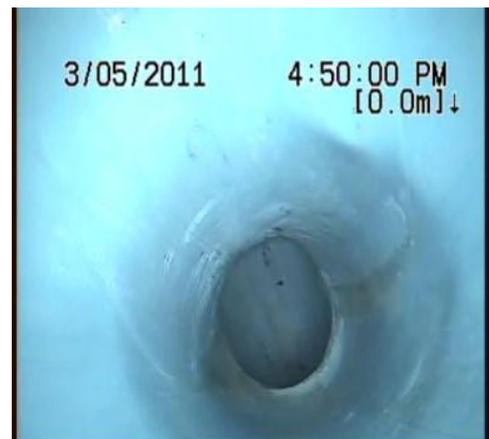
Results after reline

Nuflow Albury Wodonga performed another successful reline project!

Downtime on bathroom: We commenced the procedure at 10am and had both liners set and bathroom fully operational in the early afternoon.
