# Tungamah Town Pool Project Tungamah, Victoria

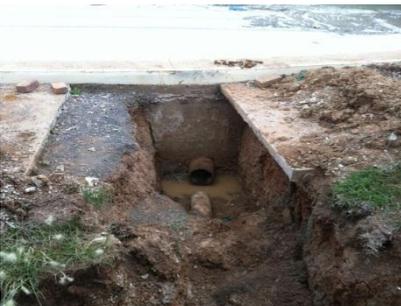
On our arrival we found a large empty concrete pool surrounded by an enormous excavation that had been made by previous contractors, in attempts to locate the water leak. The pipe was cut open at the point at which the pipe came through the limits of the concrete pool, which was used for our upstream access. The pump line went to a covered pit in the deepest point in the pool which was used as downstream access for the lining process.

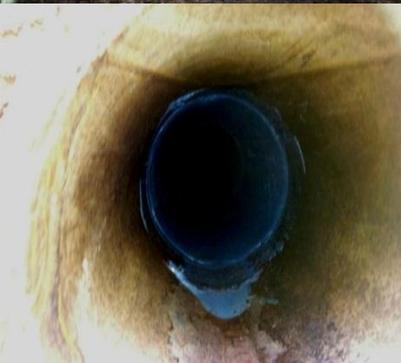
After viewing our CCTV footage of the pipe it became apparent the leak was attributed to the poor condition of this aged AC pipe beneath the concrete pool. The line required jetting to remove scale and debris washed into the pipe from recent rains before lining commenced.

**Nuflow Albury Wodonga installed another successful reline!**

Excavation: None required.

Length of Liner: 14.7m - installed in two individual sections.

Type of resin used: Slow cure

Downtime: no interference with adjacent school as the liner was installed in the afternoon and left overnight with slow cure. The pool was able to be refilled immediately at the time of bladder removal.
